January 16, 2007
Ref: #4300-86

CHALFONT BOROUGH

GUIDELINES FOR DETERMINING CONCRETE CURB AND SIDEWALK TO BE REPLACED

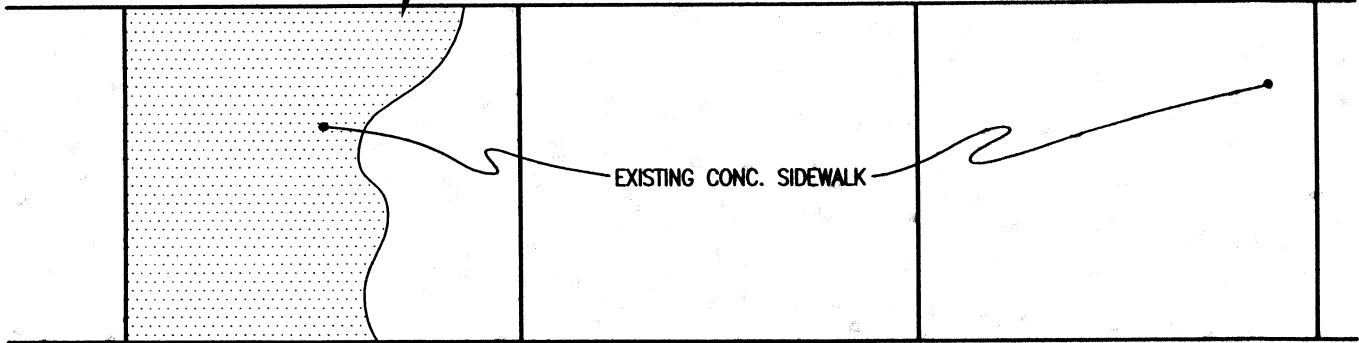
EXHIBIT 1

GREATER THAN 25% OF
DETERIORATION

PLAN VIEW

SIDEWALK REPLACEMENT DUE TO DETERIORATION

1. More than twenty-five percent (25%) of the surface of a sidewalk section or apron slab is deteriorated. (Exhibit 1)
2. More than twenty-five (25%) of a section of concrete curb has deteriorated. (Exhibit 2)

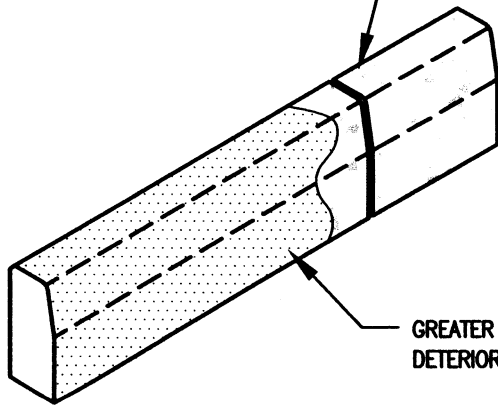
EXHIBIT 2

ELEVATION

GREATER THAN 25% OF
DETERIORATION

EXISTING CONC. CURB

CURB REPLACEMENT DUE TO DETERIORATION
